**IN THE UNITED STATES DISTRICT COURT
FOR THE EASTERN DISTRICT OF VIRGINIA
Norfolk Division**

**PLAINTIFF'S DISCLOSURE
OF REBUTTAL EXPERT TESTIMONY**

Response to Statement by GSCM Mann re Rudolf Report

Rudolf Response to 3D Marine USA Expert Report of 5 January 2025

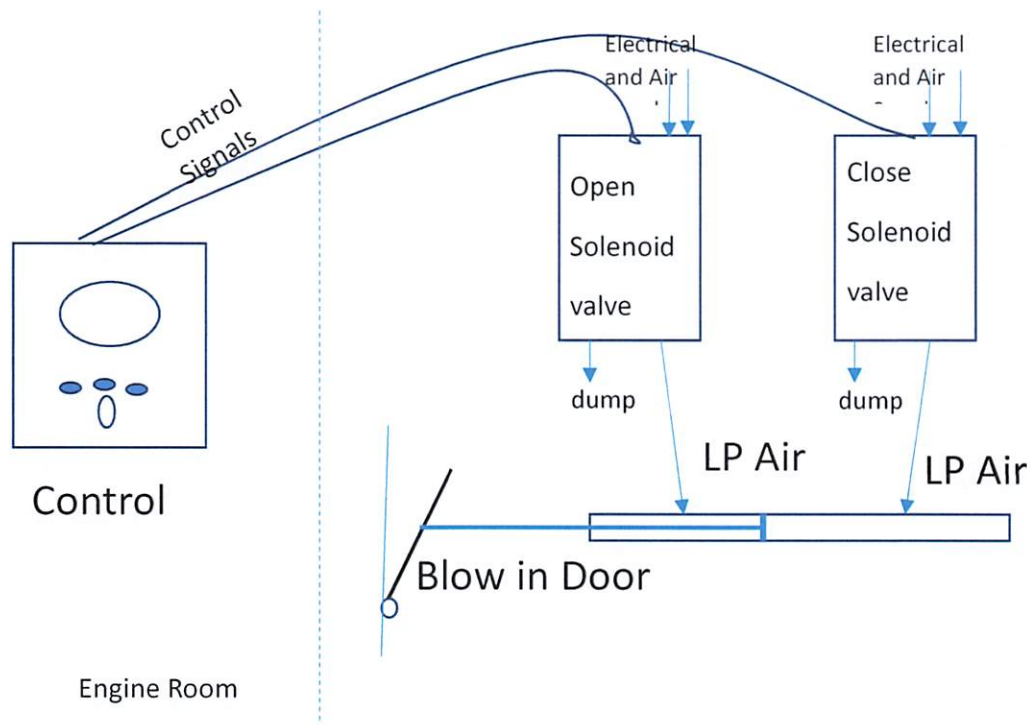
11. My original understanding of the system design was a double - acting solenoid valve per door that functions both as a door closing and opening actuator, I have consulted the BID Tech manual and have revised my simplified figure 4. of my report to include two solenoid actuators (See below).

Nevertheless, this change in no way reflects my position that if the cylinder were activated with air pressure to open the door and subsequently the air pressure were secured the door would remain in the open position until it was manually closed (manual closing of the door would present no hazard to maintenance services (unless it was forced) or to personnel). Plus, it would satisfy the recommendation of the WAF to tagout the door in the open position. Leaving LP air on the system presented a hazard to both maintenance services and personnel.

GSMC Mann attempts to justify that leaving air pressure applied to the system would not only keep the door open but satisfy the Waf Request. It does nothing to eliminate the hazard of inadvertent door closing under pressure.
